GT750 Waterpump Drive Gear Repair By Lane Pipkin Goose Creek, SC, USA

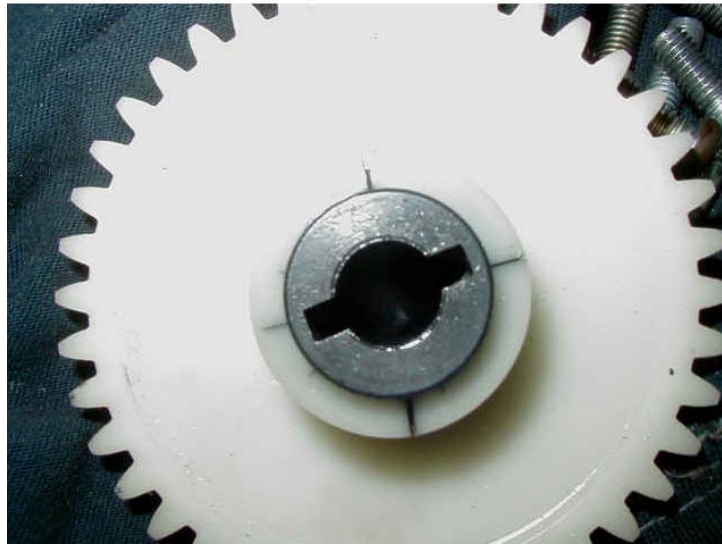
GT750 waterpump drivegears are known for cracking. The gears are getting more scarce and expensive, so I devised a cheap, easy repair.

Purchase a 28mm split-collar and clamp it to the cracked gear.

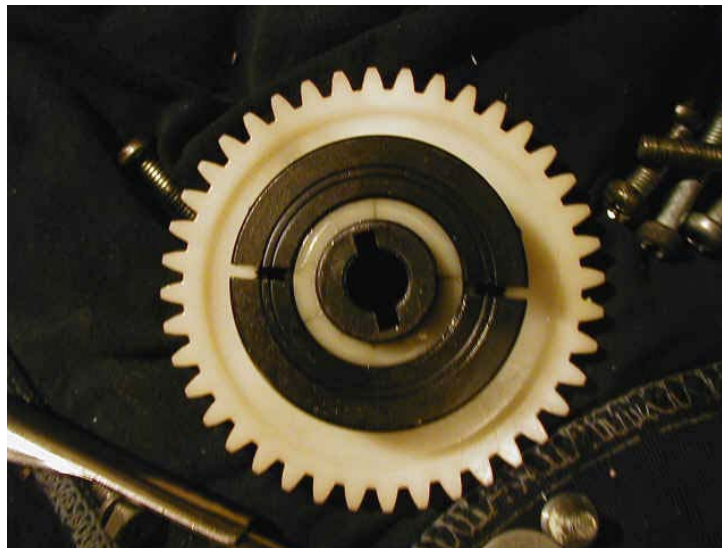
This repair does cause a interference problem with a screw behind the gear, so the screw has to be modified.

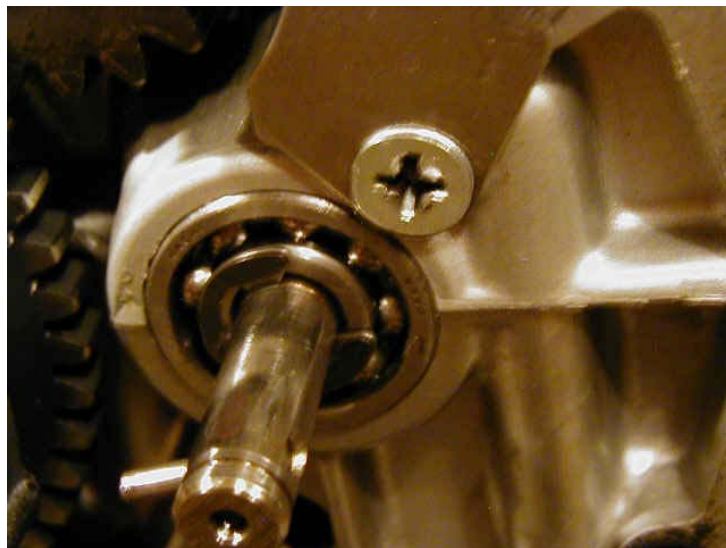
After replacing the screw, there is plenty of space for the collar.
